Appendix D4

Updated Arborist Report (MBA 2007)

**Post-disturbance Arborist Report Update
Martin Ranch Project Site
Unincorporated San Bernardino County, California
San Bernardino North, California, USGS 7.5-minute**

August 2, 2007

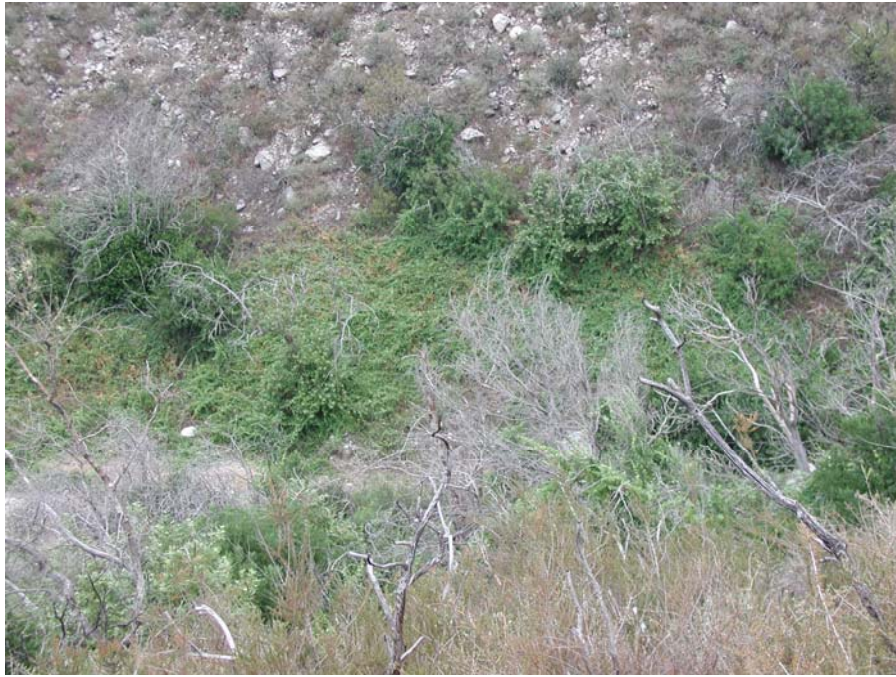
Figure 1. This is a northern most CWW located within a tributary of Cable Creek; there is an increased presence of poison oak and wild grape.

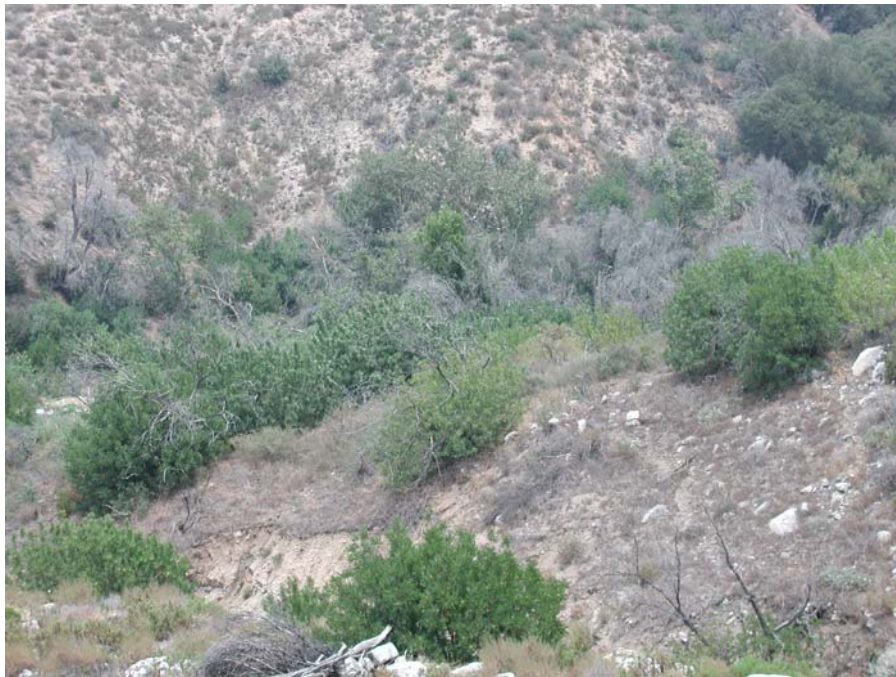
Figure 2. This is a western view of the regenerated SSARW at the northwestern portion of the site. There is a noted absence of white alder.

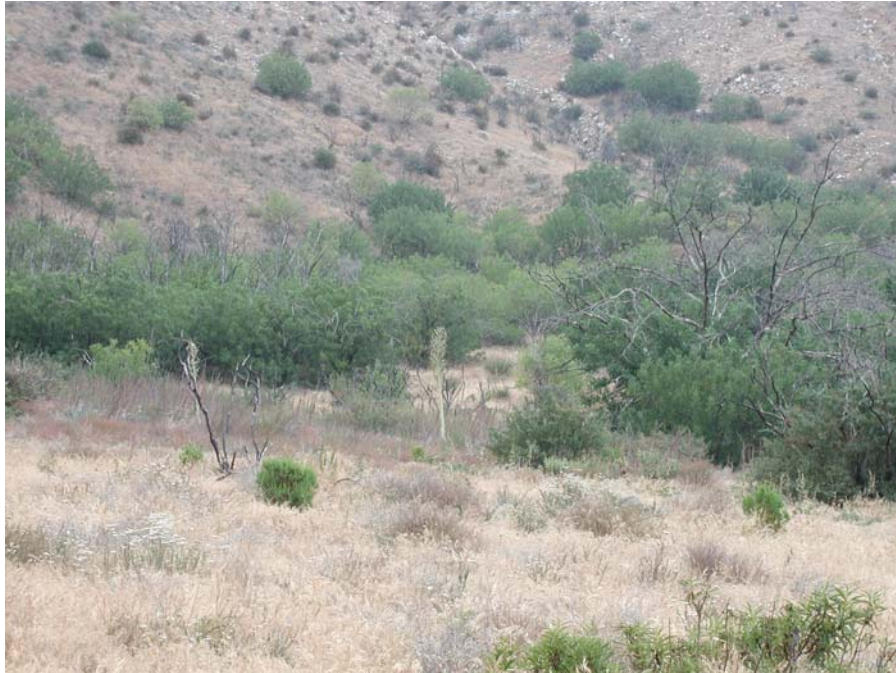
Figure 3. This is an eastern view of the regenerated CWW located at the northeastern portion of the site.

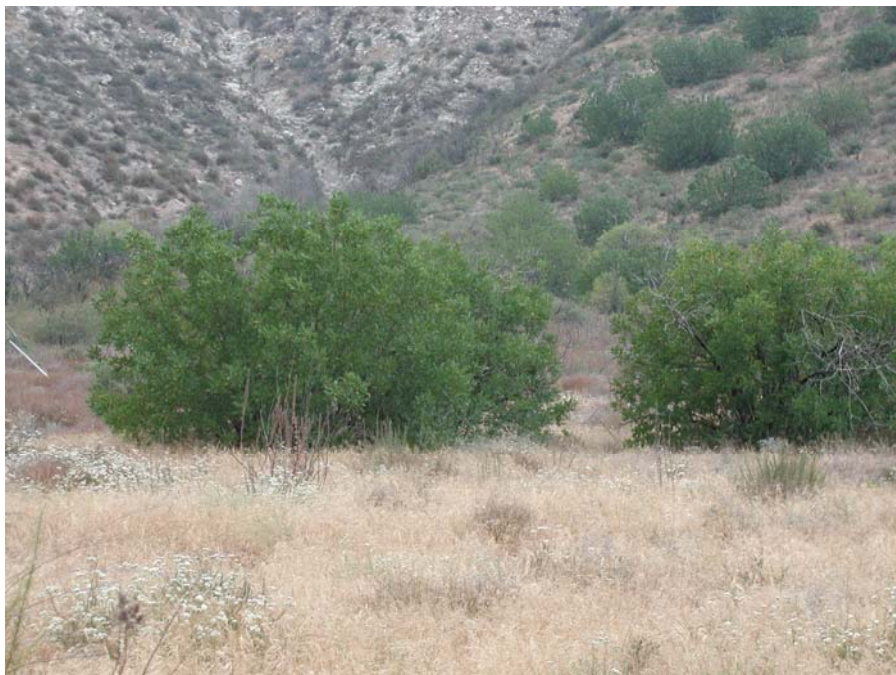
Figure 4. This is a northern view two California walnut trees that had regenerated from basal structures following the fire disturbance.

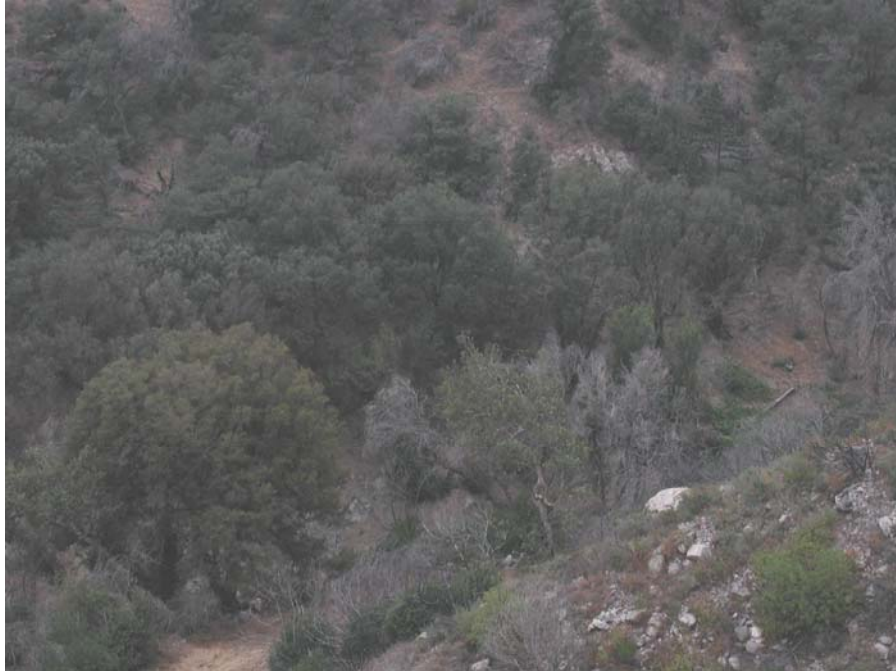
Observation: This woodland too has recovered from the 2003 Old Fire with sprout regeneration and other survival mechanisms. The apparent CBI index value for this community type ranged from 1.0 to 3.0 where remnants of the fire disturbance indicated 10-100 percent consumption of the vegetation canopies. At this intensity, vegetation litter was likely removed. This tree community had adapted to the disturbance by basal resprouting if the canopy had been consumed or by epicormic sprouts if the canopy had been partially damaged. Epicormic shoots are sprouts from limbs and are an indicator that the tree had been impacted and is adapting or is stressed. The primary species noted during the survey within the CLOW were canyon oak, Ca bay, and CA walnut, Ca sycamore. Canyon live oaks are known to resprout vigorously, and disturbance can also enhance seed recruitment creating a positive outlook for this habitat following fire disturbance. Recovery in this vegetation community however, appeared to be the slowest among the communities surveyed due to the slow growth typically seen in canyon oak.

Figure 5. This is a western view of the canyon live oak woodland at the northwest corner of the project site.

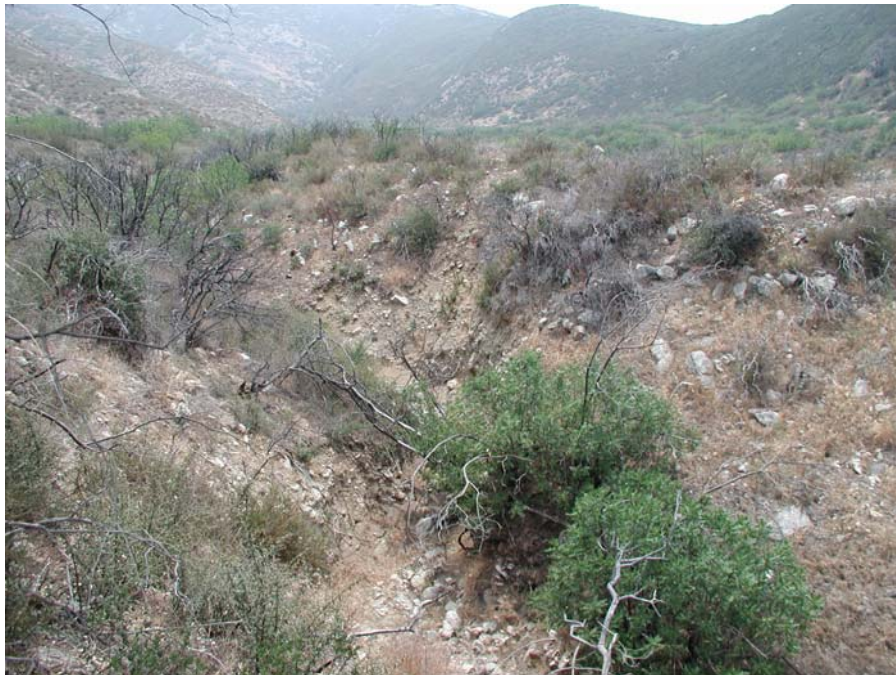
Figure 6. This is northern view of the RSS/CWW located within the central interior of the site.

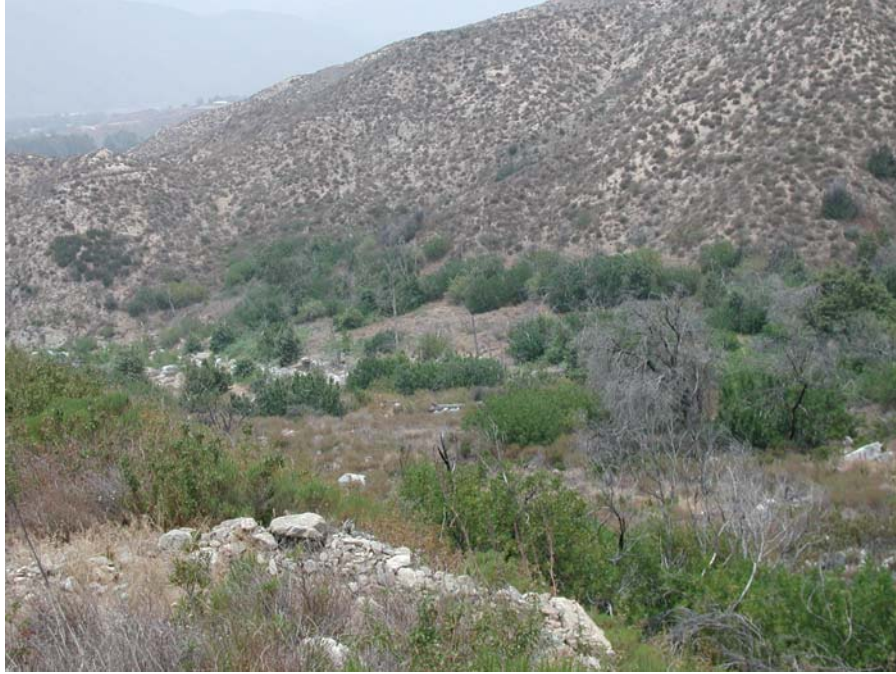
Figure 7. This shows the convergence of SAW and CWW located at the northwest corner of the site.

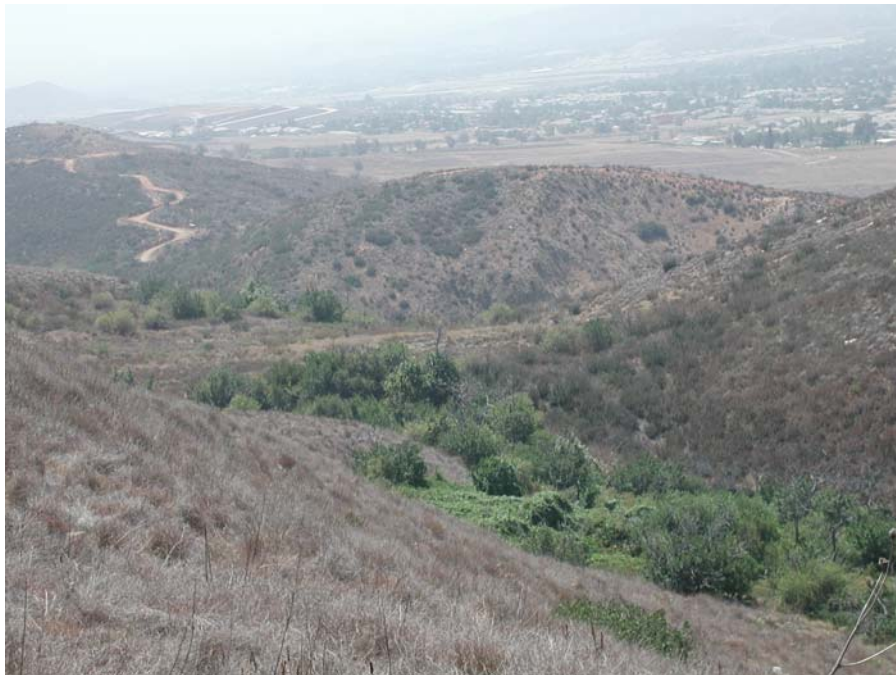
Figure 8. This is an eastern view of the CWW extending from the southern portion of the SWS/CWW documented in the biological report of 2007.

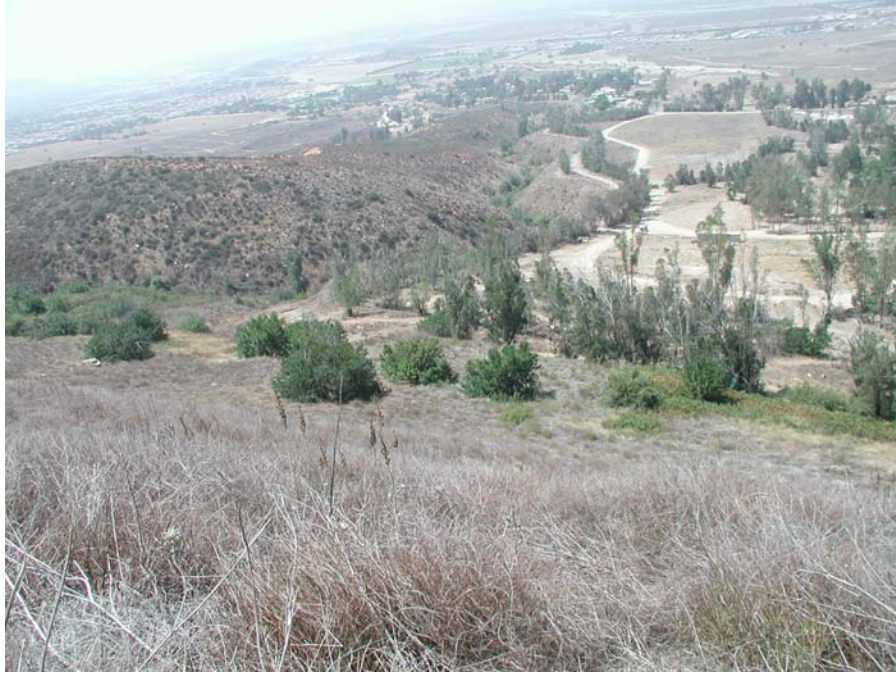
Figure 9. This is an eastern view of the same CWW extending west to the just north of the RSS/EUC community.

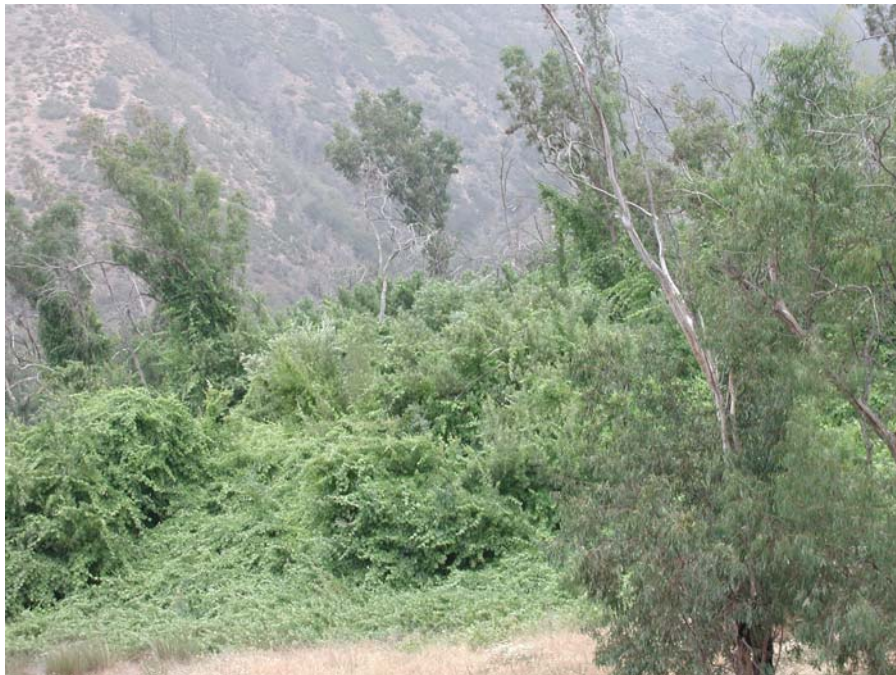
this intensity, vegetation litter was mostly removed. This community had resiliently recovered to where new growth had sprouted almost completely masking evidence from the disturbance. This species is known to recover well from fire resprouting vigorously when top-killed by fire; it is also known as a seed recruiter following disturbance. The primary species noted during the survey within the SWS red and arroyo willows, canyon oaks, mulefat, Mexican elderberry, sycamore, and CA fig. Interestingly, wild grape had prolifically rebounded following the fire and aggressively competes for resources to the point of covering much of the willows (see photo in Appendix A below).

Figure 10. This is a northern view of the SWS community at the northeastern portion of the site. Wild grape has taken advantage of the disturbance and currently out-competes the willows for sunlight.

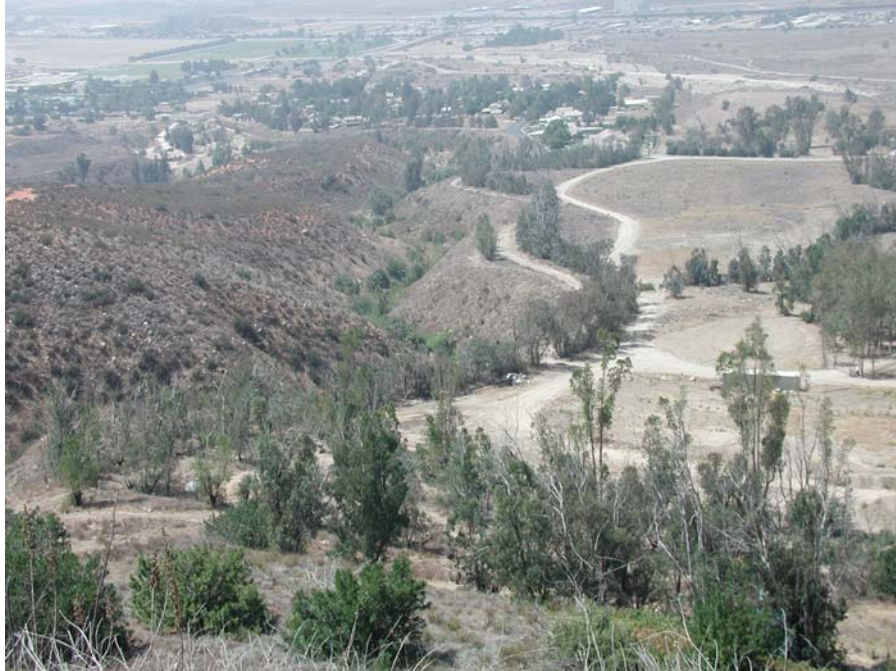
Figure 11. This is a southern view of the SAW (in ravine) community and stand of gum trees that extend to the southern boundary of the property.

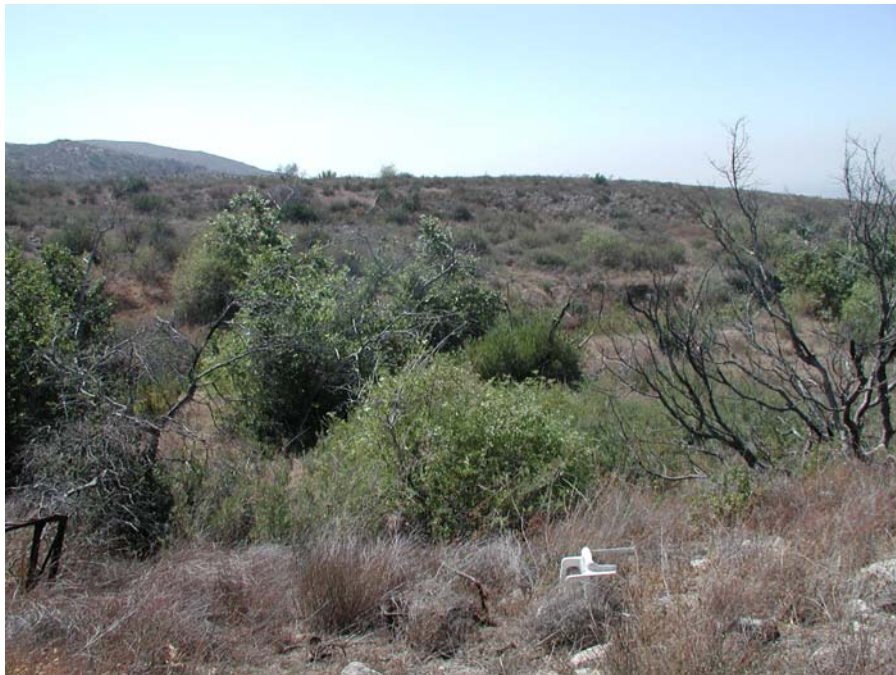
Figure 12. This is an eastern view of the SAW along the eastern boundary of the site.

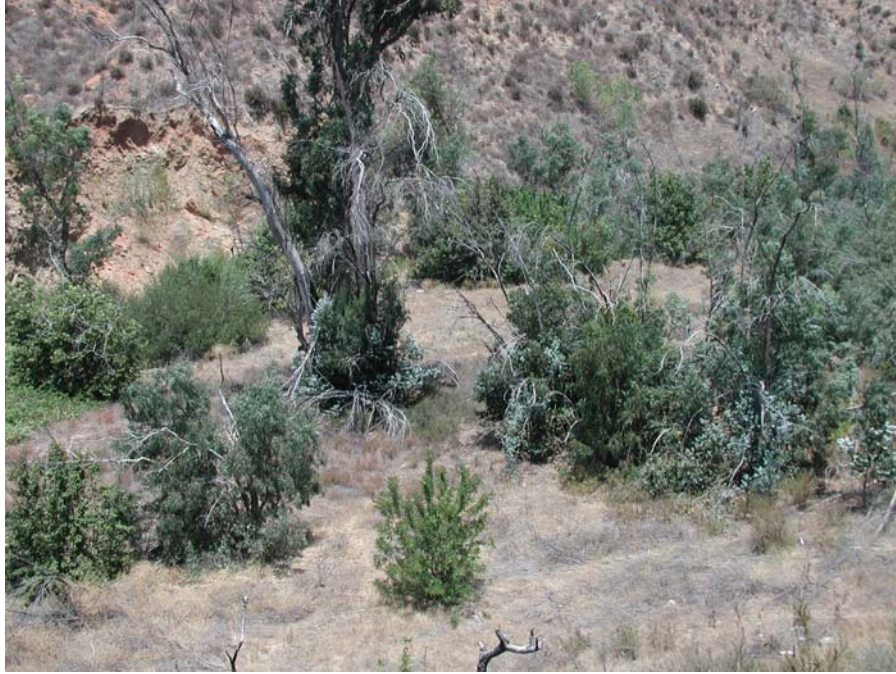
No white alders were found during the surveys as their numbers had been substantially reduced by the impacts of the 2003 Fire. It is likely, however, that they may be present in reduced numbers, but as basal sprouts or in sapling form. There are conflicting reports as to their primary mode of re-establishment after a fire, but they are not known to be strong regenerators. Until the alders re-establish themselves as a dominant species, this essentially changes the vegetation communities types they were once a part of from southern sycamore-alder riparian woodland to sycamore alluvial woodland.

Figure 13. This is a western view of the SSARW community located at the southeastern portion of the site. Here too, there is a noted absence of white alder.

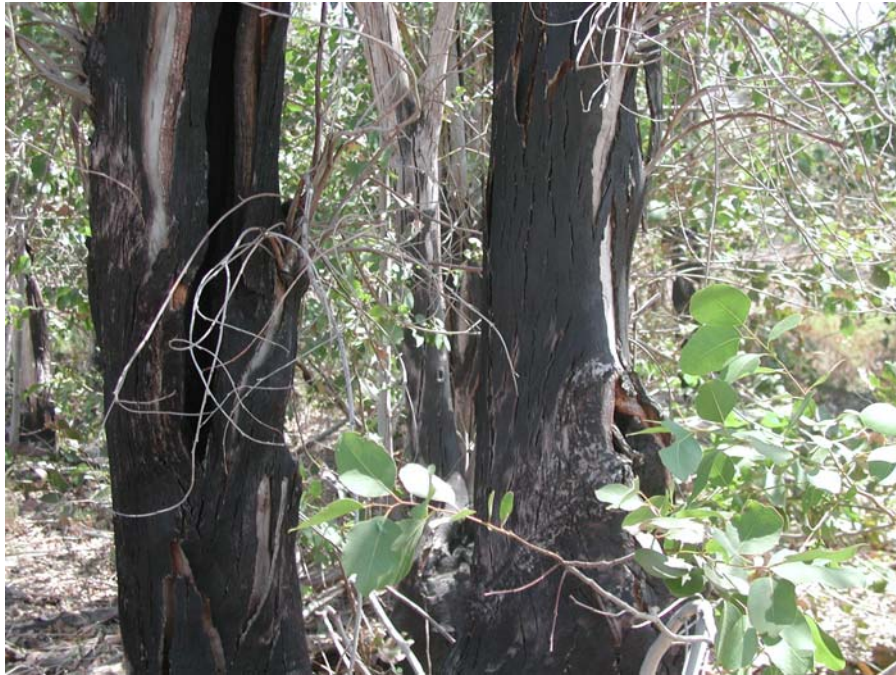
Although the focus was on native tree species, the gum trees (*Eucalyptus sp.*) were generally assessed as a group. These trees are not native to California, but have been imported for use as fuel and windbreaks. In many instances, these trees have been attacked by pests and show signs of decay and

structural damage from the fire. The wood is dense and heavy, and they present a potential risk if these damaged trees fail. These trees shall be independently evaluated if they are to remain as part of the project; this is imperative given the residential nature of the proposed project.

The gum trees that remain within the project site occur with varying degrees of fire damage. The stands of gum trees onsite vary in condition from dead to undisturbed. Many stands adjacent to housing structures were left unimpacted, perhaps as a result of the nearby structures being aggressively protected by fire agencies. There were *Eucalyptus* species that had been severely impacted, especially those adjacent to or located within wildlands. These trees need to be individually assessed if they are to be preserved in place. Potential hazards were noted during the field assessment that included dead trees and limbs as well as scorched, burnt out, and diseased trunks all indicating potential poor structural integrity.

Figure 14. This image of a gum tree illustrates its regenerative characteristics. The stem has been hollowed out by fire and poses a potential threat of structural failure.

Many of the trees onsite pose a significant failure hazard to the public if not removed. It is recommended that all trees identified as diseased or hazardous be removed and replaced according to City guidelines. All landscaping involving this mitigation shall be performed by a firm experienced in tree maintenance and who can demonstrate this to the satisfaction of the Planning Department. Many of these trees are unstable and are unsuitable as landscape trees within a residential development. If any gum trees are to remain as part of the landscaping within the proposed project, each gum tree shall be individually assessed and mitigated for.
