# **Delineation of Jurisdictional Wetlands and Waters**

## **Spring Trails Specific Plan, San Bernardino County, California**

**July 28, 2009**

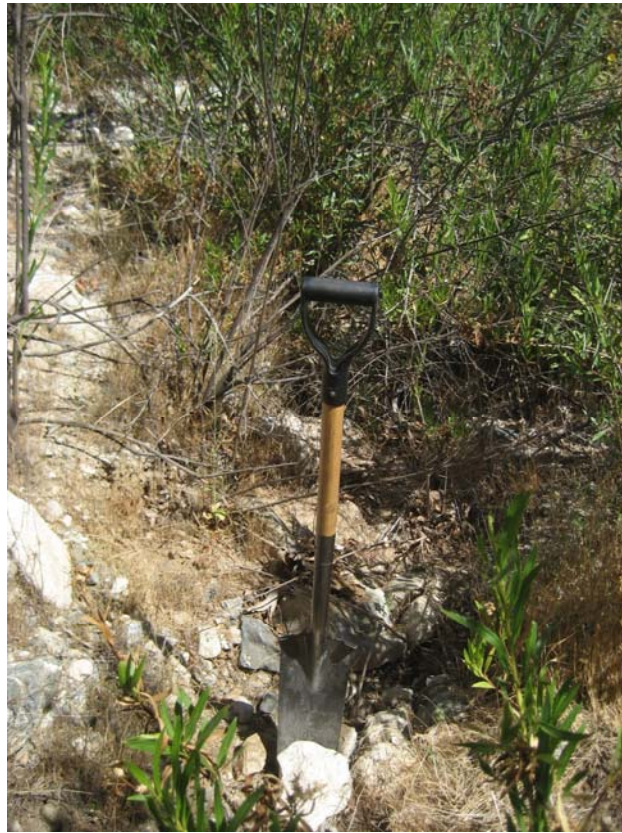
Photo 1: Upstream view of sample pit taken at DP01 within lower reach of Tributary 2, facing north. Field data confirmed the absence of wetlands within this area.

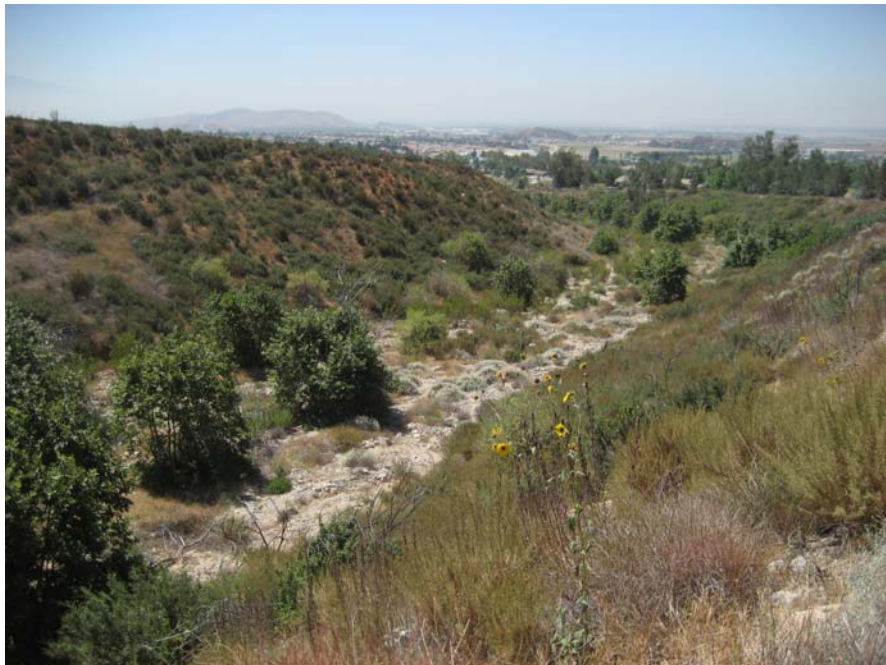
Photo 2: Downstream overview of lower reach of Tributary 2 within the project site, facing southwest.

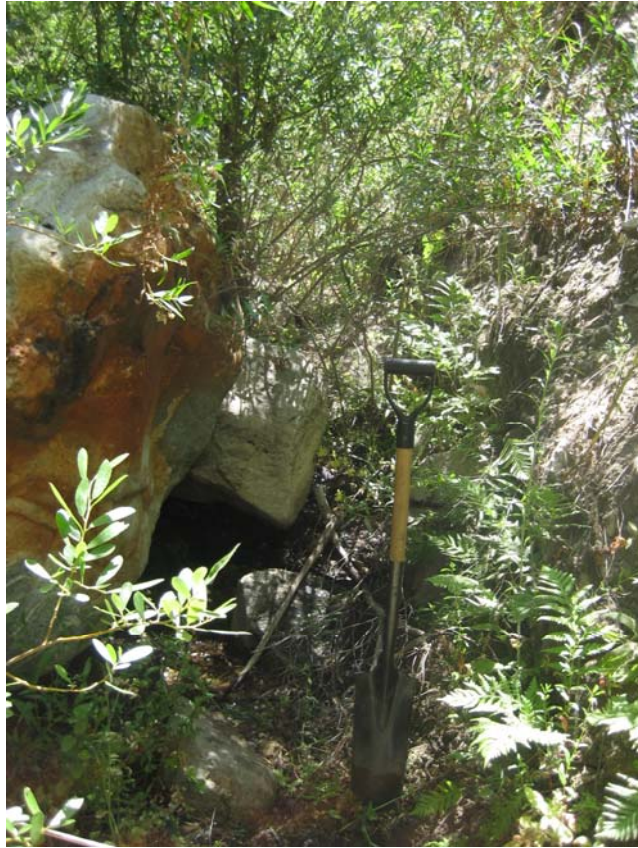
Photo 3: Upstream view of DP02 within middle reach of Tributary 2, facing northeast. Surface flows were observed and field data determined the presence of wetland conditions within this area.

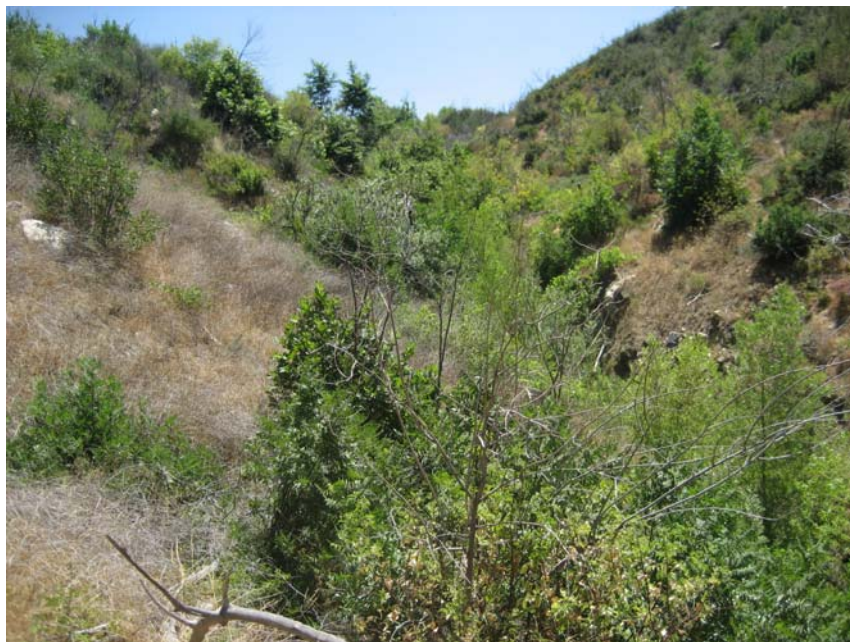
Photo 4: Upstream view of middle reach of Tributary 2, facing east. A steep grade and narrow channel was observed within this section of Tributary 2.

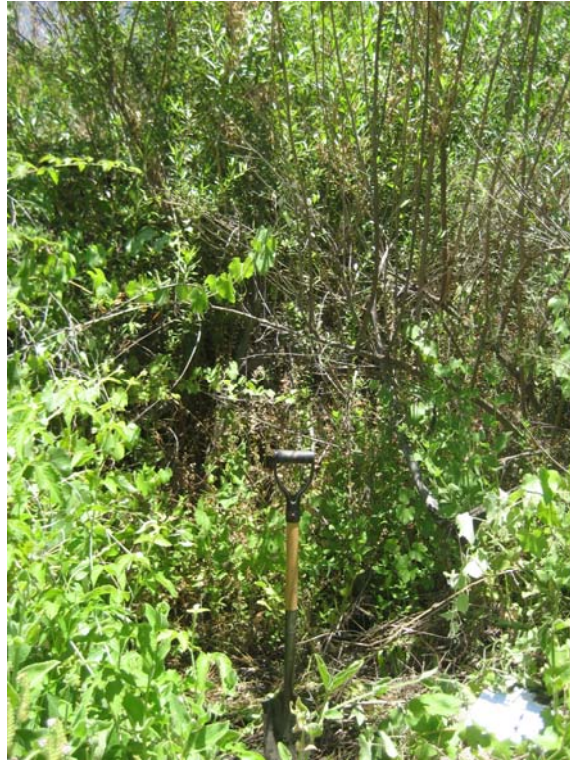
Photo 5: Cross-sectional view of DP05 taken within the lower reach of Tributary 10, facing northeast. Wetland conditions were confirmed at this location.

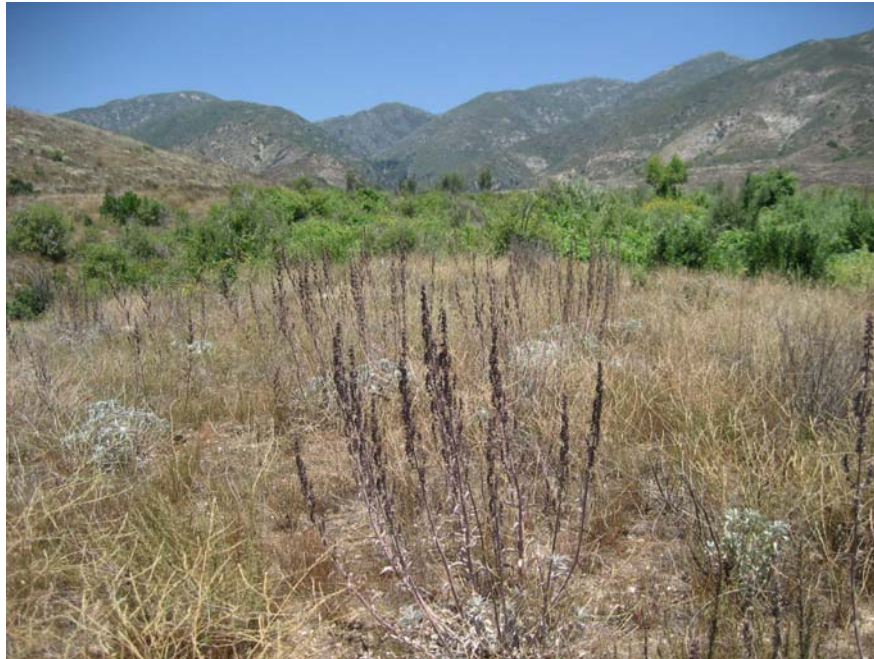
Photo 6: Overview of western portions of seasonal wetland area in southern-central portions of the site, facing north. The seasonal wetland is depicted in the mid-ground and adjacent uplands in the foreground.

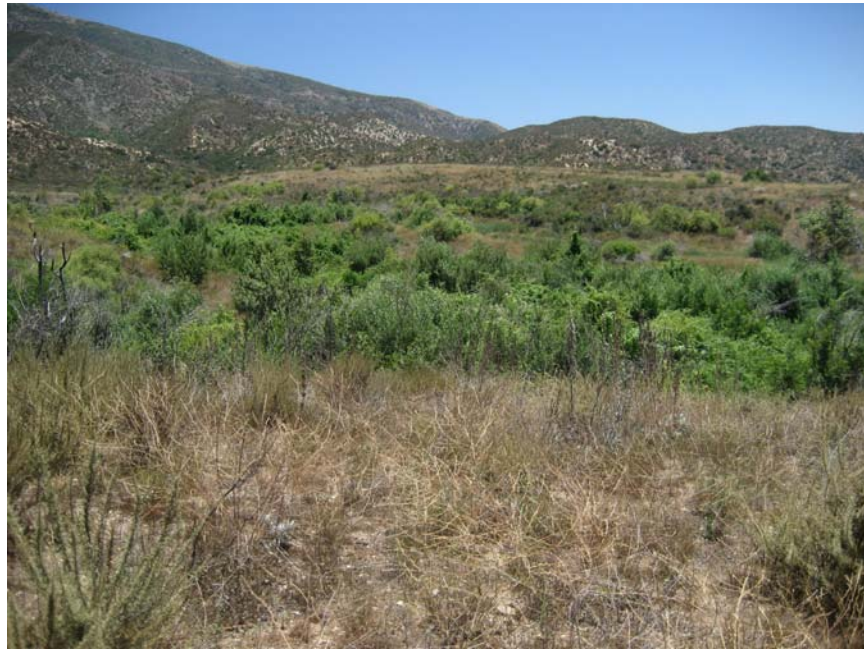
Photo 7: Overview of eastern portions of seasonal wetland area in southern-central portions of the site, facing north.

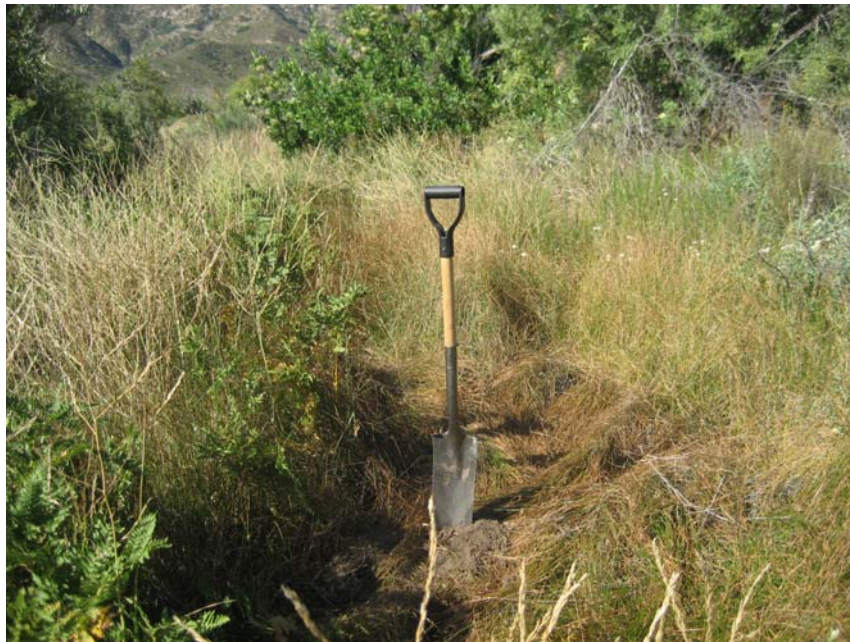
Photo 8: North-facing view of DP03 taken at the riparian drip-line within the middle reach of Tributary 2. No wetland conditions were determined to exist at this location.

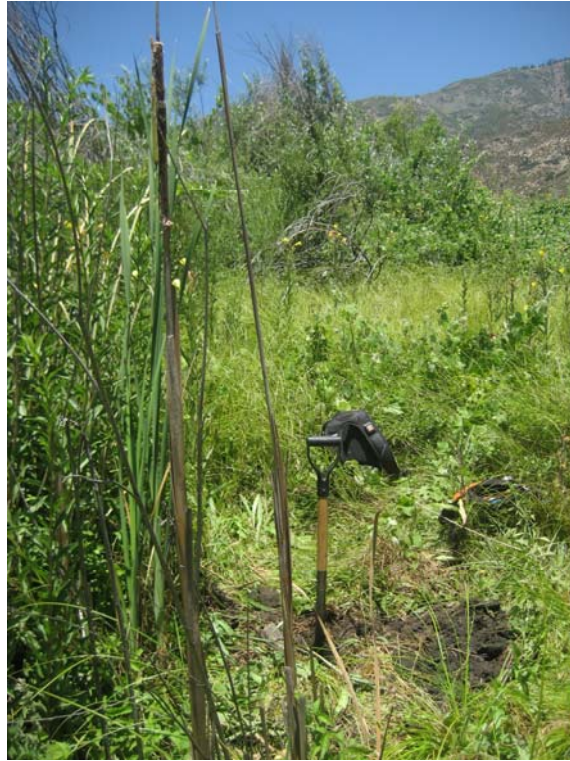
Photo 9: View of sample pit taken at DP06 within seasonal wetland area, facing north. This area was determined a potential problem area due to the lack of obvious hydric soil indicators, but dominance of hydrophytic vegetation and presence of hydrology indicators.

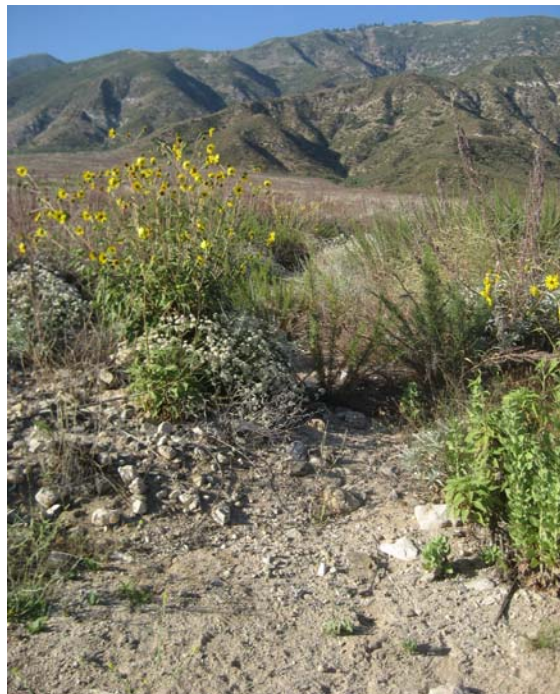
Photo 10: Upstream view of Tributary 9 taken upstream of seasonal wetland area, facing north. This feature is one of four ephemeral erosional features that occur in the central portions of the site.

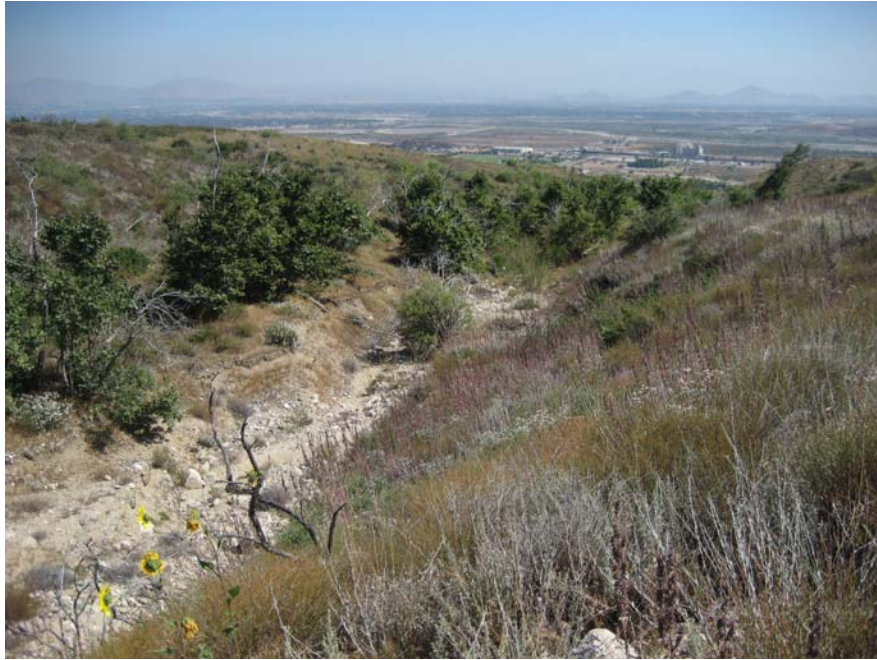
Photo 11: Downstream overview of upper reach of Tributary 2, facing south.

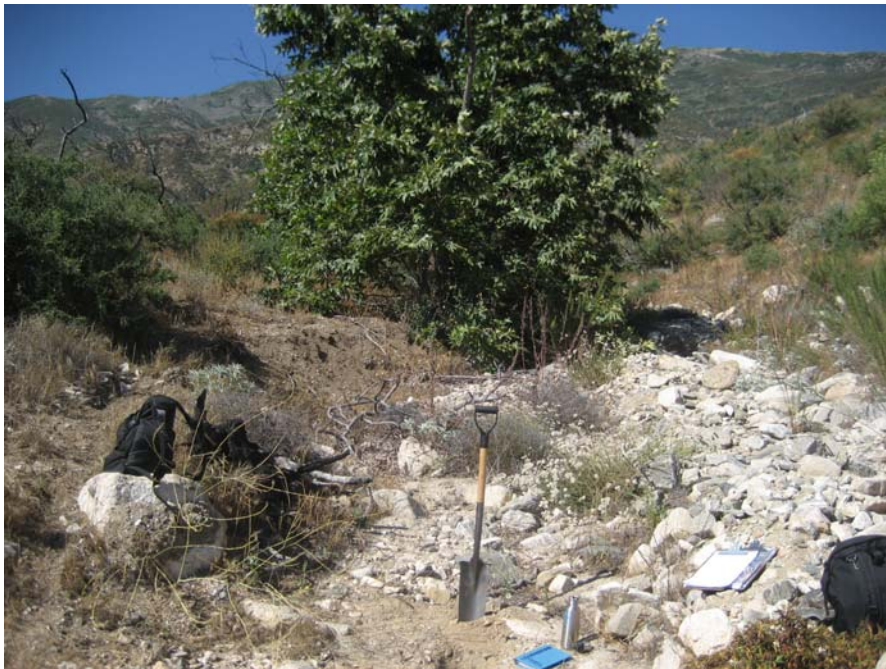
Photo 12: View of sample pit taken at DP04, facing north and upstream. No wetland conditions were determined to exist at this location.

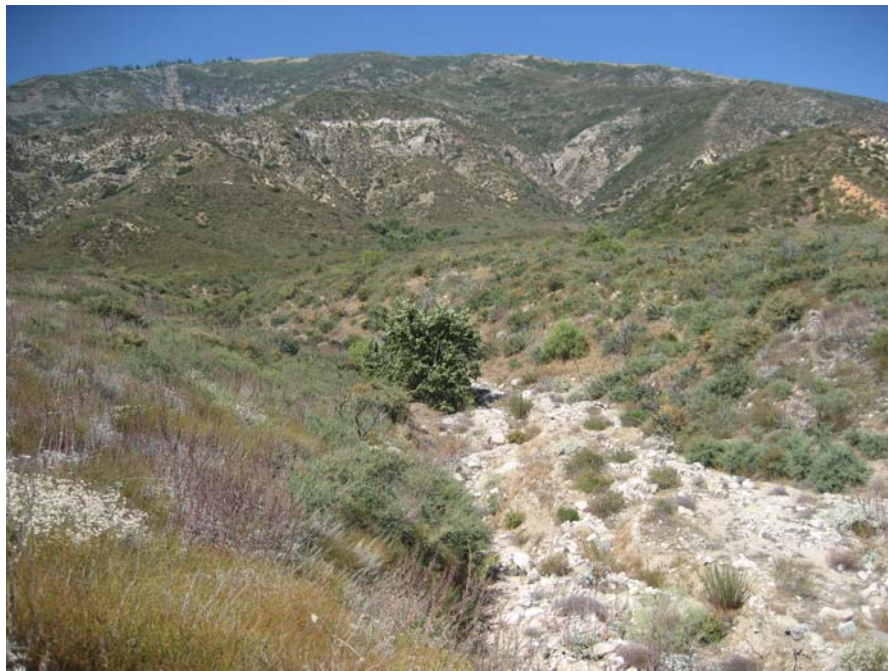
Photo 13: Upstream overview of upper reach of Tributary 2, facing northeast.

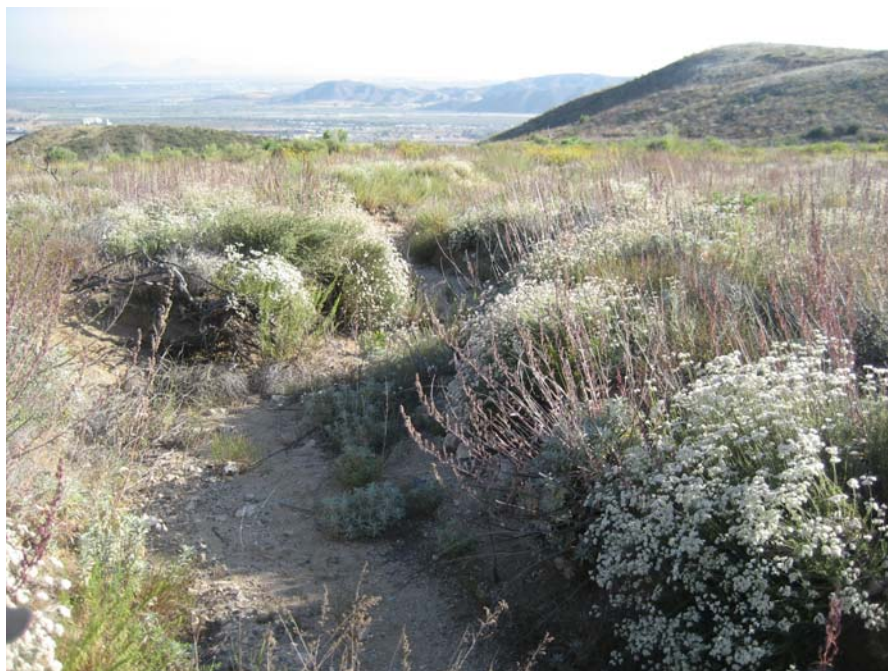
Photo 14: Downstream view of lower reach of Tributary 8, facing south. Tributary 8 is one of four ephemeral erosional features that traverse the central portions of the site.

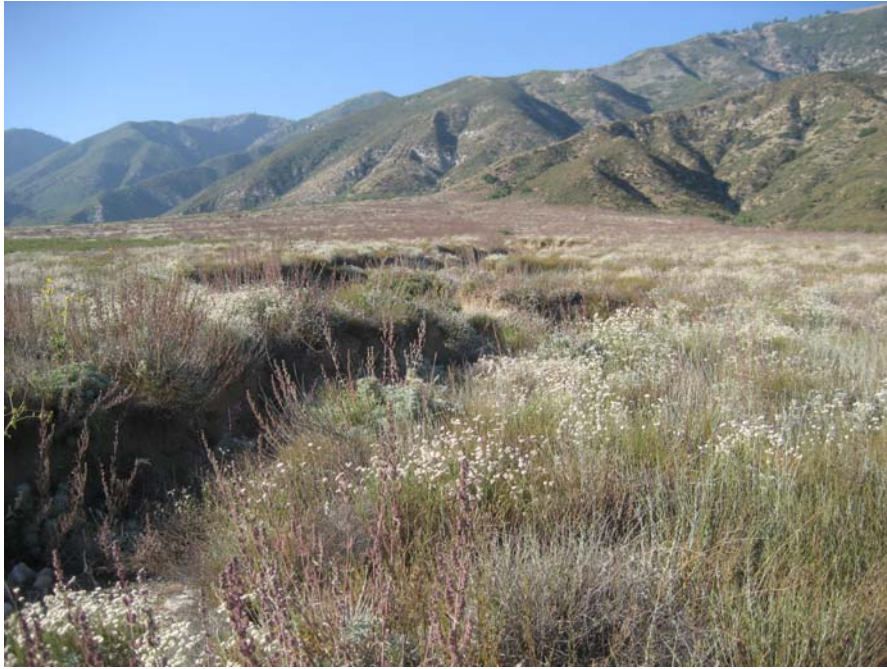
Photo 15: Upstream view of middle reach of Tributary 8, facing north. Note incised banks and dominance of homogeneous, upland alluvial fan sage scrub.

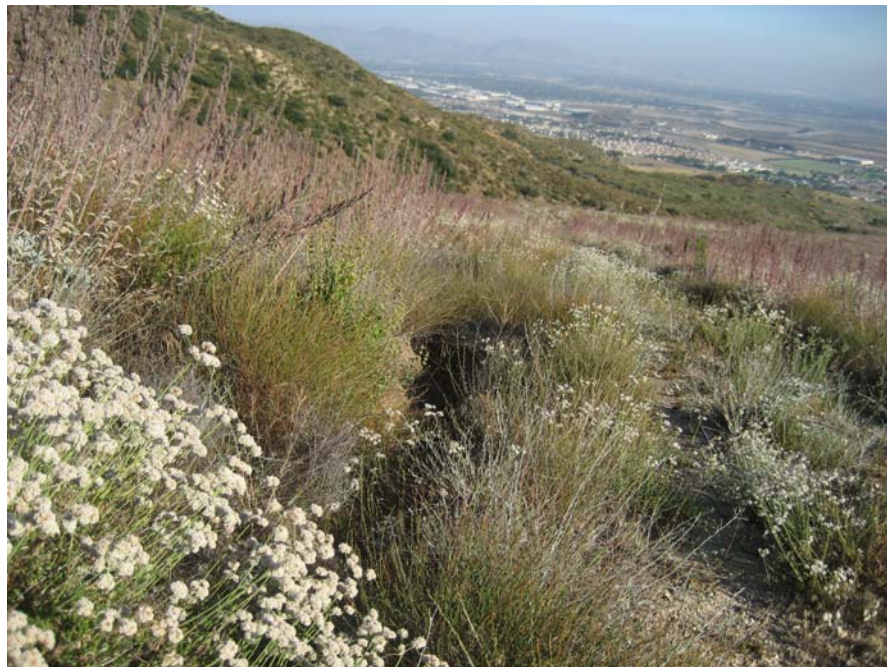
Photo 16: Downstream view of upper reach and origin of Tributary 7, facing southwest. This feature runs parallel to an existing dirt access road (depicted on right side of photo) throughout its entire reach. Tributary 7 is one of four ephemeral erosional features that drain the alluvial fan in the central portions of the site.

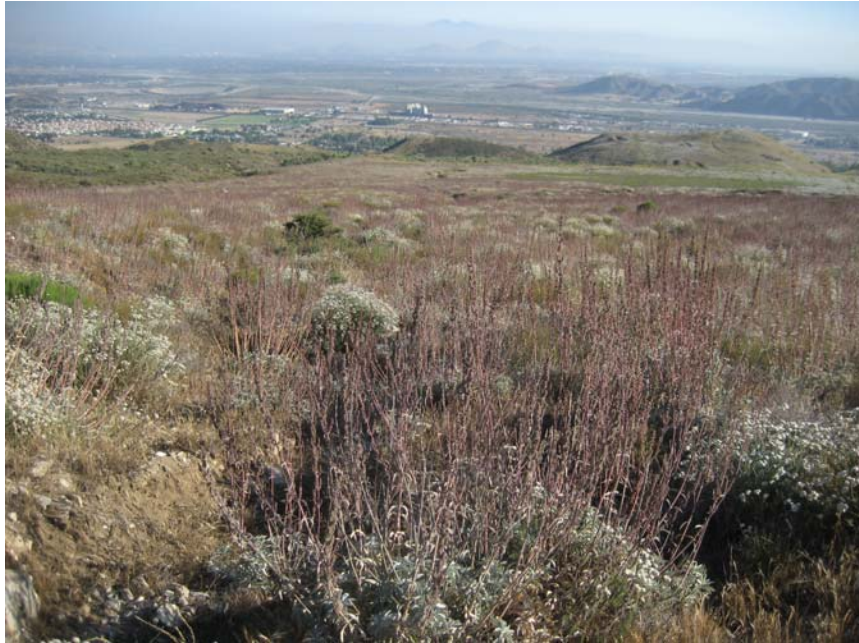
Photo 17: Downstream view looking across the alluvial fan at the middle reach of Tributary 8, facing southwest.

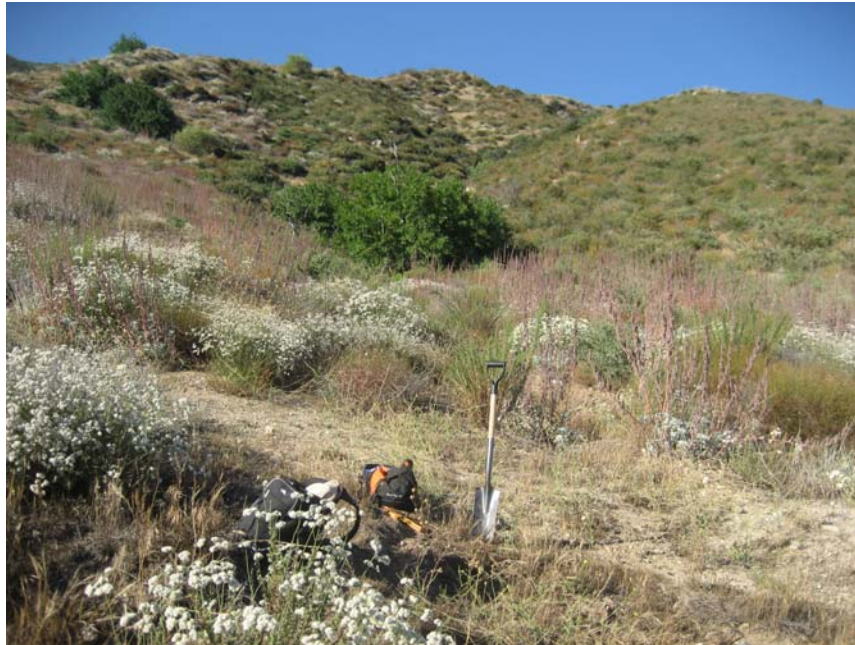
Photo 18: Upstream view of upper reach of Tributary 8, facing northeast. The headwaters and watershed for Tributary 8 are depicted in the background.

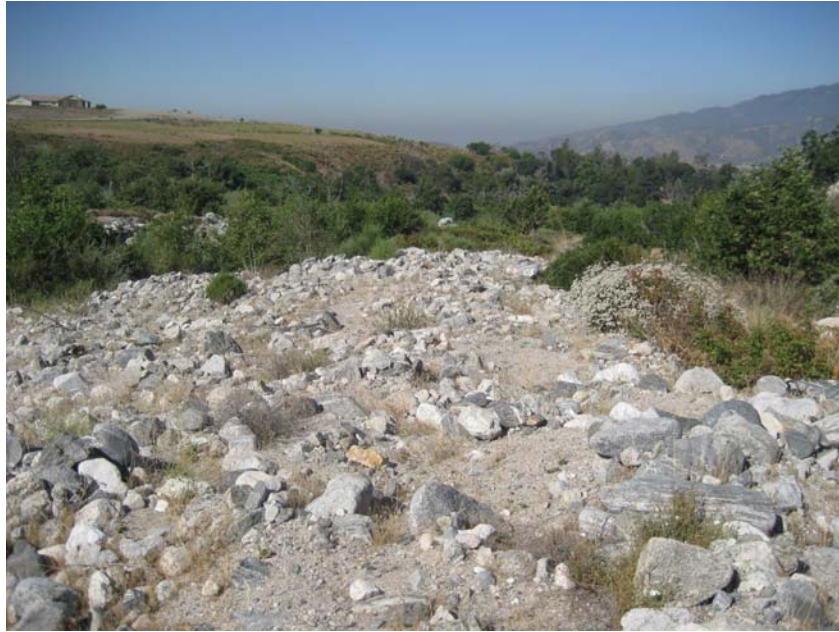
Photo 19: Downstream overview of lower reach of Cable Creek floodplain as it discharges from the site, facing southwest. Note broad bench and terrace in foreground and riparian canopy along main channel in background.

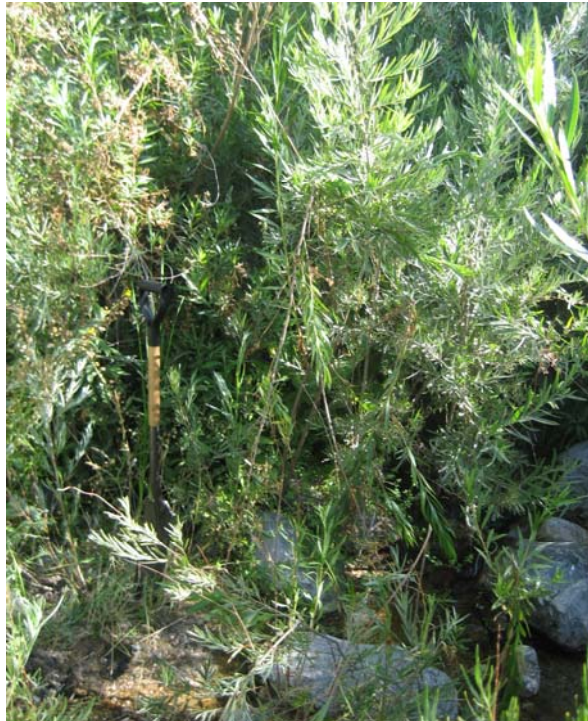
Photo 20: View of sample pit taken at DP07 within lower reach of Cable (Canyon) Creek, facing southeast. This sample point was taken at an access point immediately downstream and west of the project site. Perennial flows and wetland conditions were observed within the active channel at this location.

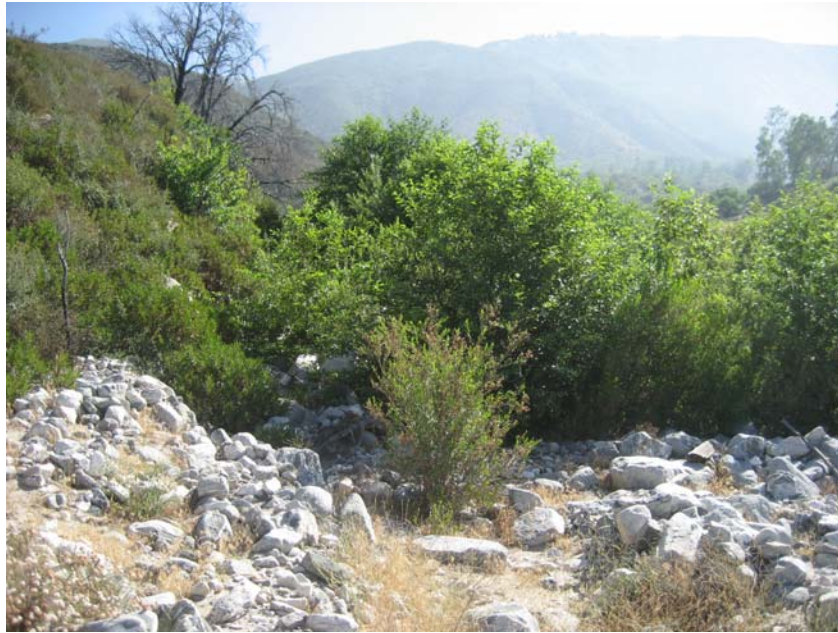
Photo 21: Upstream view of lower reach of Cable (Canyon) Creek, facing northeast. Photo taken from upland bench. Note sycamore-alder-willow riparian canopy associated within active channel in mid-ground.

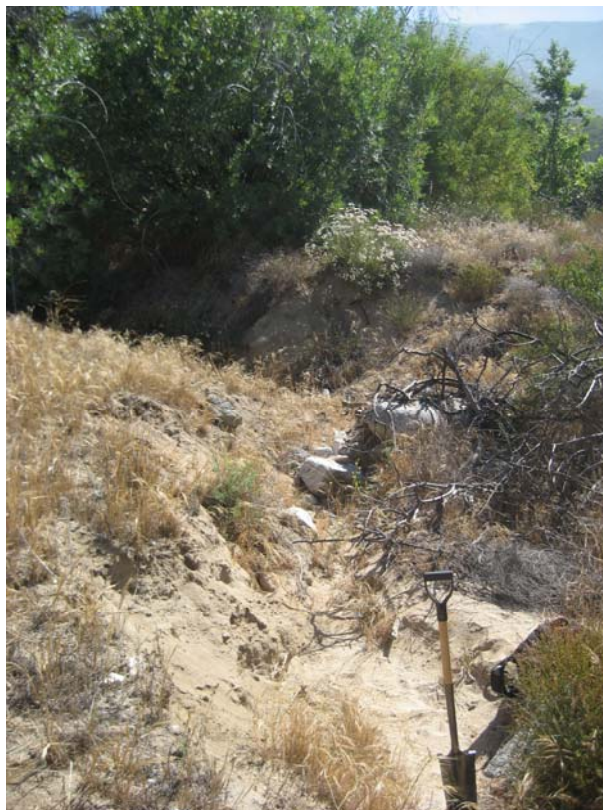
Photo 22: Upstream view of lower reach of Tributary 11, facing north.

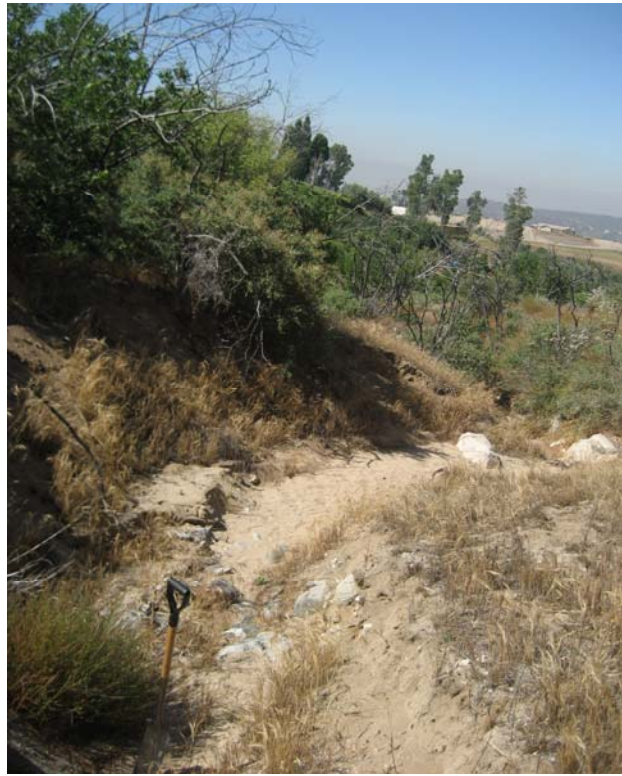
Photo 23: Downstream view of lower reach of Tributary 11, facing north. Cable (Canyon) Creek is depicted in background.

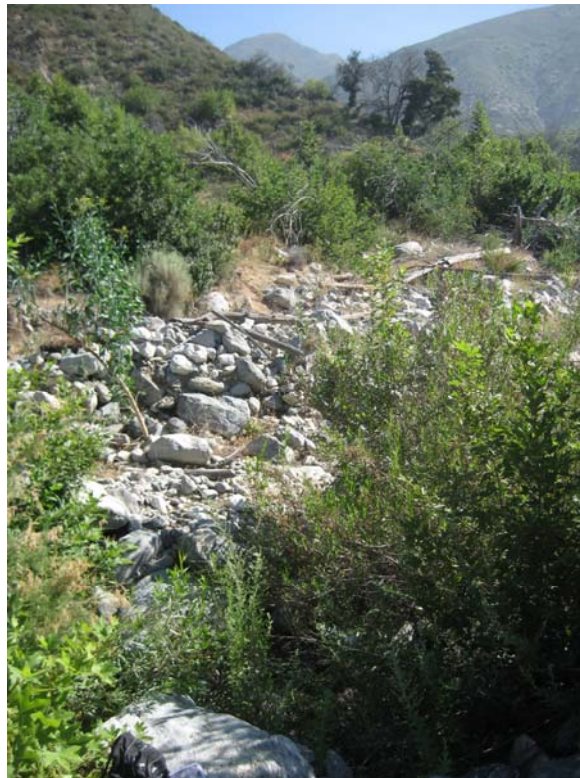
Photo 24: Upstream view of middle reach of Cable Canyon, facing north.

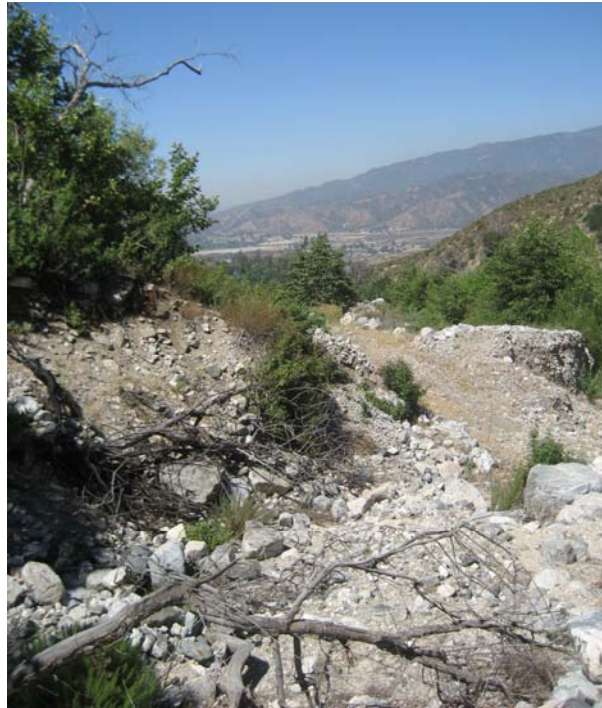
Photo 25: Downstream view of lower reach of Tributary 17 and confluence with Cable Canyon, facing west.

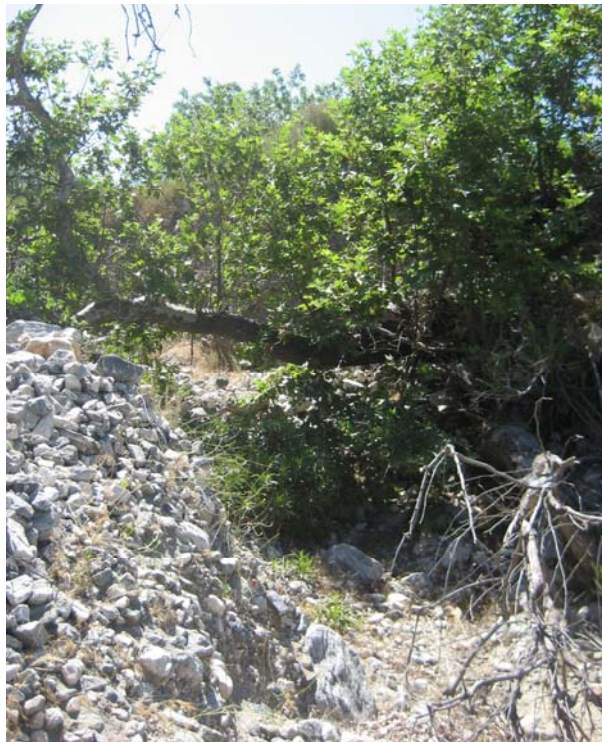
Photo 26: Upstream view of lower reach of Tributary 17, facing east.

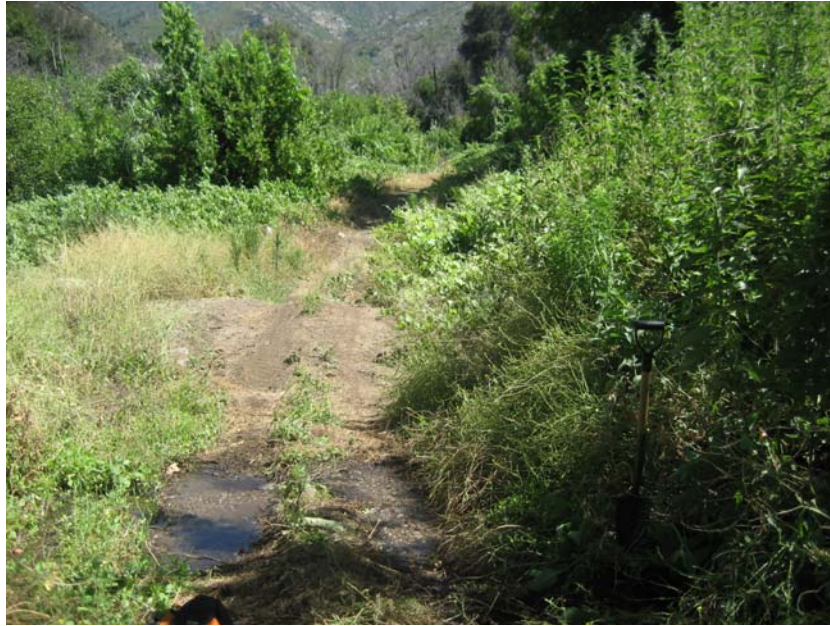
Photo 27: View sample pit taken at DP08, facing north. Normal conditions are not present at this location as it occurs below the outfall drain and valve switch for a plastic water pipe. The area is occasionally subjected to artificial inundation when the valve is open.

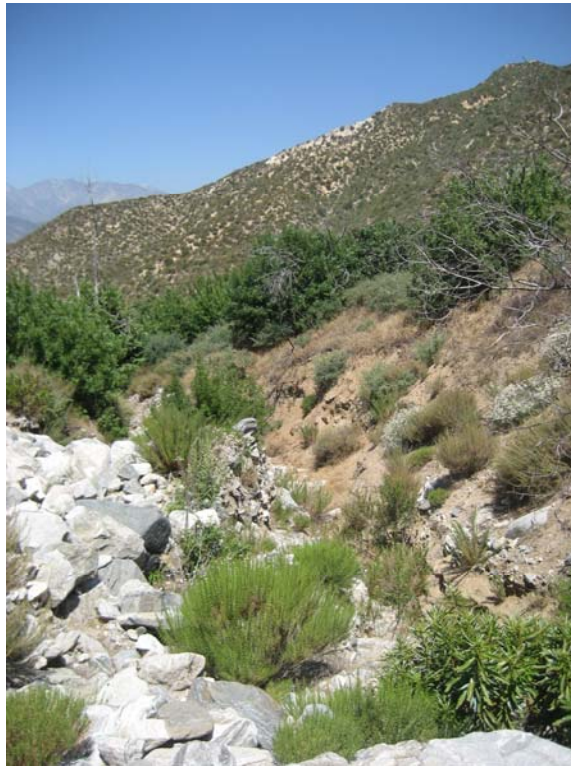
Photo 28: Downstream view of lower reach of Tributary 17, facing west.

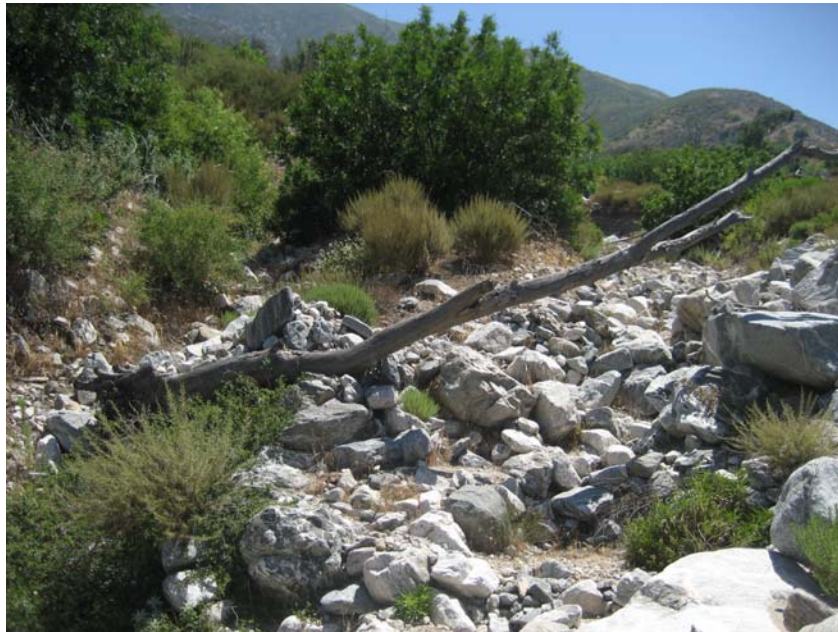
Photo 29: Upstream view of middle reach of Tributary 17 (foreground and right) where Tributary 15 (background left) converges, facing northeast.

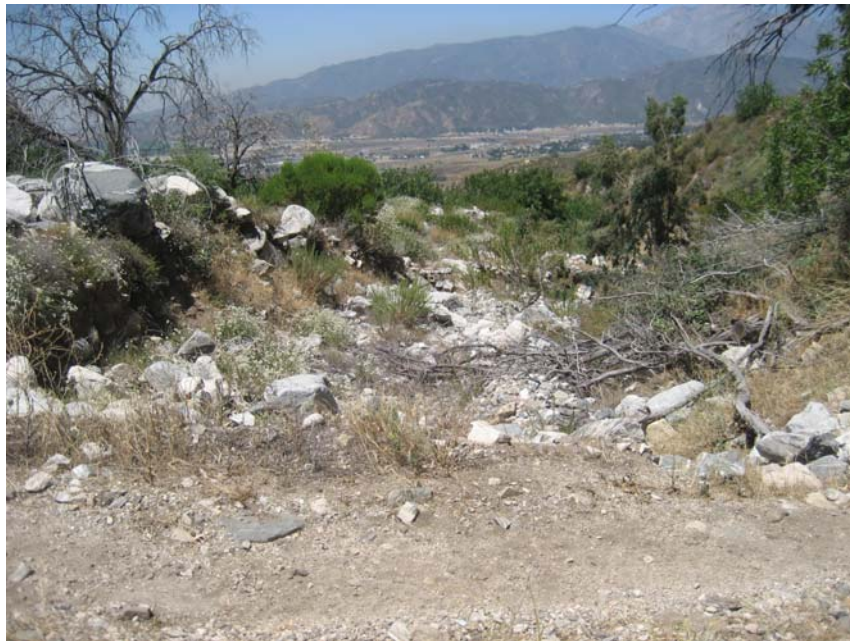
Photo 30: Downstream view of middle reach of Tributary 17, facing west. Photo taken from existing dirt access road that intersects the drainage feature.

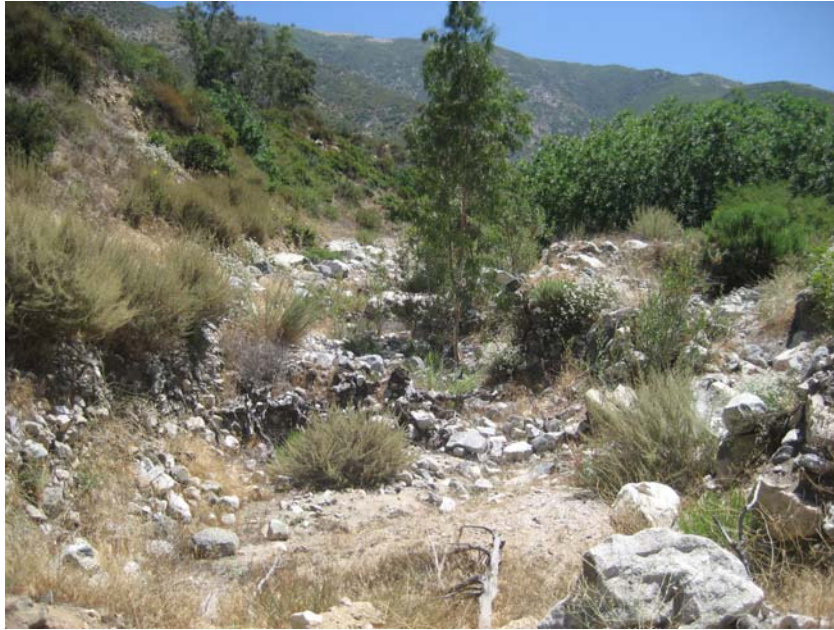
Photo 31: Upstream view of upper reach of Tributary 17, facing northeast. Photo taken from existing dirt access road that intersects the drainage feature.

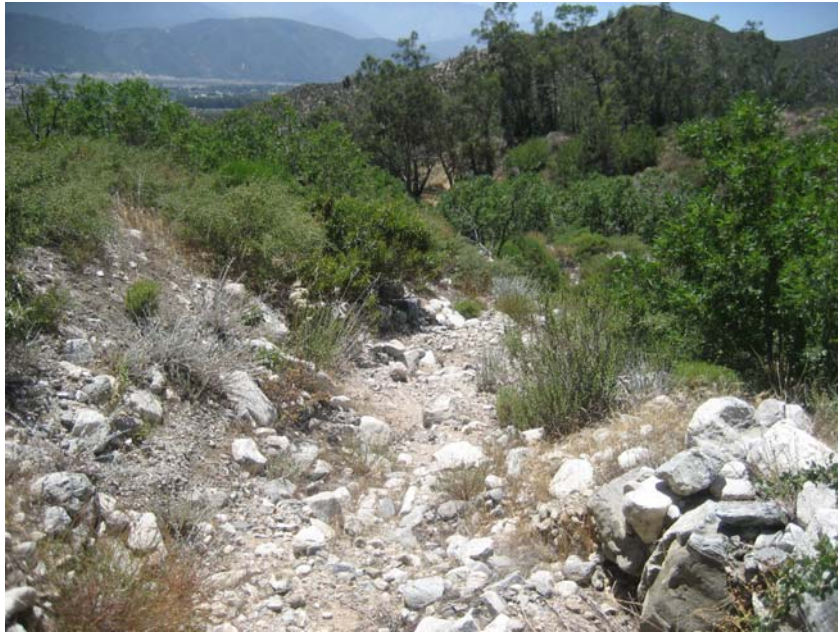
Photo 32: Downstream view of lower reach of Tributary 18, facing west. This feature converges with Tributary 17 approximately 300 feet downstream as depicted in mid-ground of the photo.

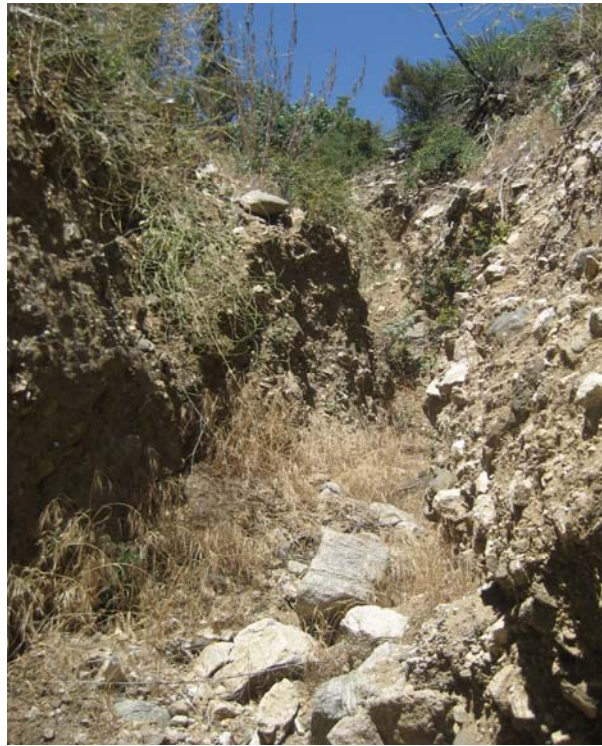
Photo 33: Upstream view of lower reach of Tributary 16, facing northeast. Photo taken immediately upstream of confluence with Tributary 17.

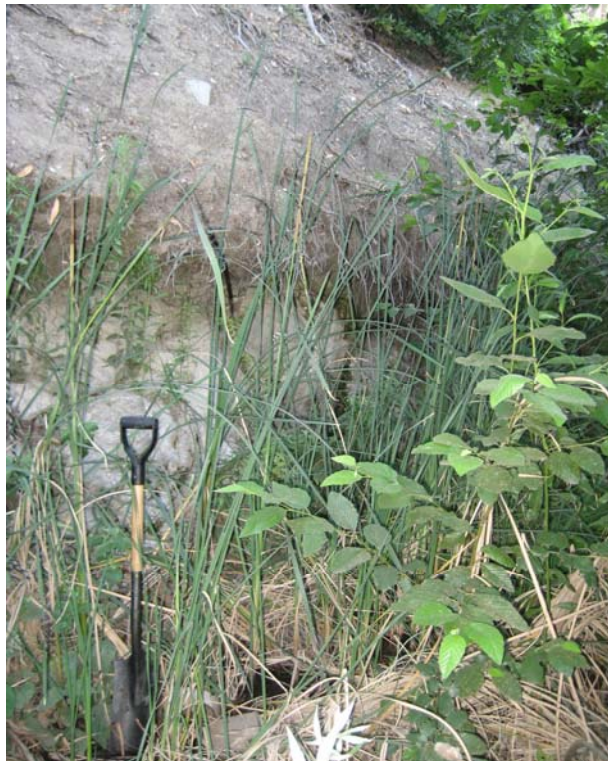
Photo 34: View of typical abutting wetland area at DP09 within upper reach of Cable Canyon (West Fork). Sample taken immediately outside of active channel.

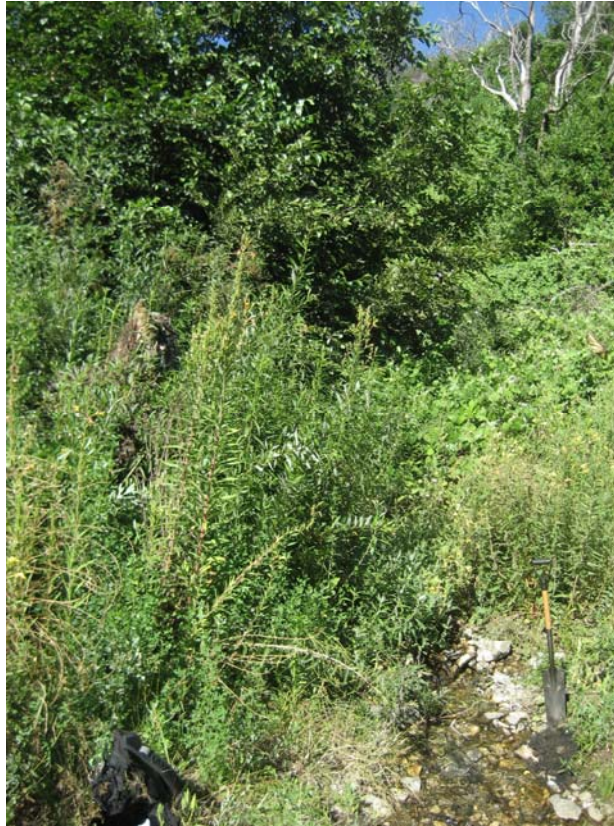
Photo 35: Upstream view of sample pit taken at DP10 within Cable Canyon (East Fork), facing northeast. Wetland conditions were confirmed abutting the active channel.

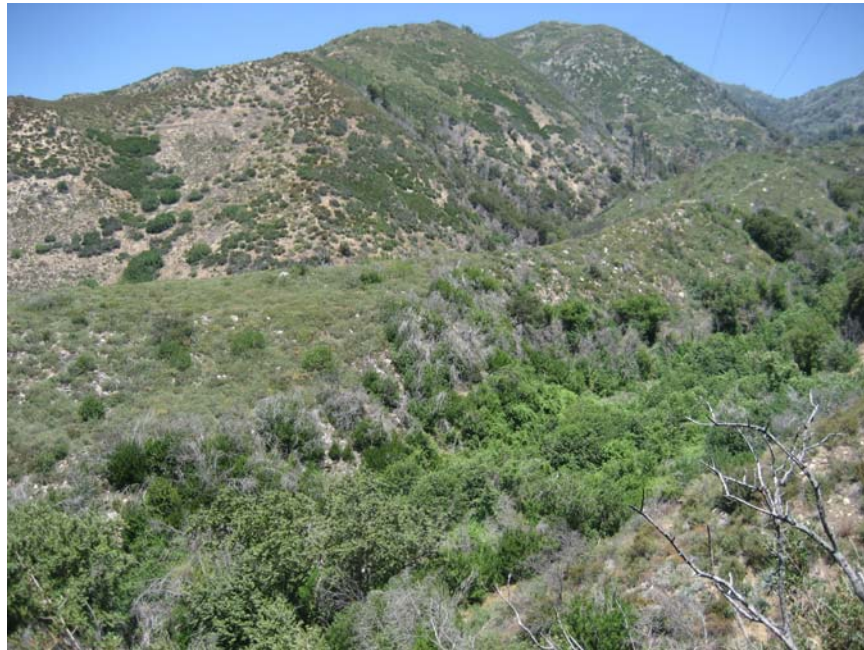
Photo 36: Overview of upper reaches of East Fork (foreground) and West Fork (background) of Cable Canyon, facing northwest. These areas were inaccessible by foot due to steep terrain and extremely dense vegetation.
